ASSESSMENT OF THE USE OF SEAT BELTS IN BUSES BASED ON RECENT ROAD TRAFFIC ACCIDENTS IN SPAIN

Ignasi Ferrer

IDIADA AUTOMOTIVE TECHNOLOGY SA

Paper Number 222

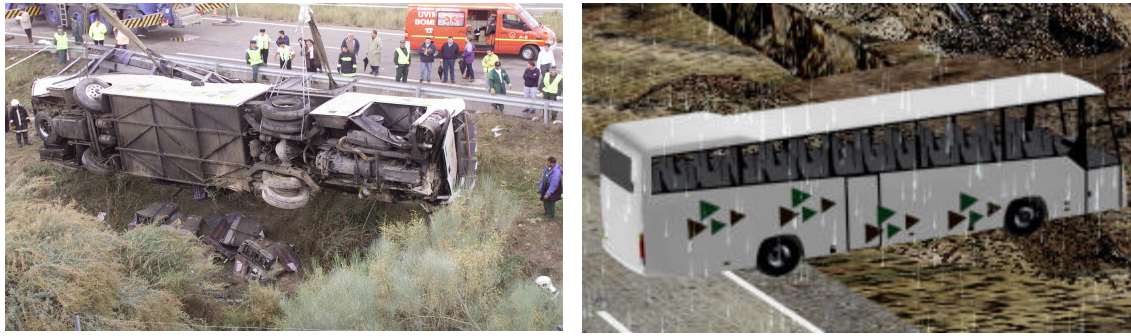
The bus consists of a chassis SCANIA K113 CLB and a body CAETANO Delta. There are 57 seating positions on it, including the driver seat and the guide seat at the front left side of the bus. The kerb weight of the bus is 13300 kg and it has two axles. The front axle is single and the rear one is double. Figure 1 shows a photograph and a drawing of the vehicle. The sequence of the accident is shown in Figure 2. The bus was driving at noon on the motorway at a speed of 106 km/h. It was raining. At a certain moment, the skidding of the rear axle started. From that moment on, the bus reeled from side to side, eventually spinning around 180 degrees, completing this turn outside the road. At the place where the bus left the road, there was no retention barrier. The bus left the road and rolled over. Right at that place where the bus fell, there was a small watercourse, with a depth of water of one meter and a half at that time.

Figure 1. Photograph and drawing of the vehicle.

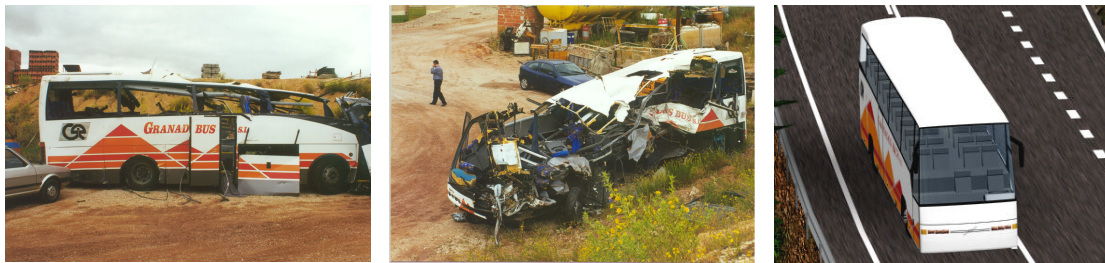
The bus consists of a chassis MAN 13230 HOCL and a body UGARTE CX Elite. There are 45 seating positions, including the driver seat and the guide seat at the front left side of the bus. The kerb weight of the bus is 13600 kg and it has two axles. The front axle is single and the rear one is double. Two photographs and a drawing of the bus are shown in Figure 4.

Figure 4. Photographs and drawing of the bus.

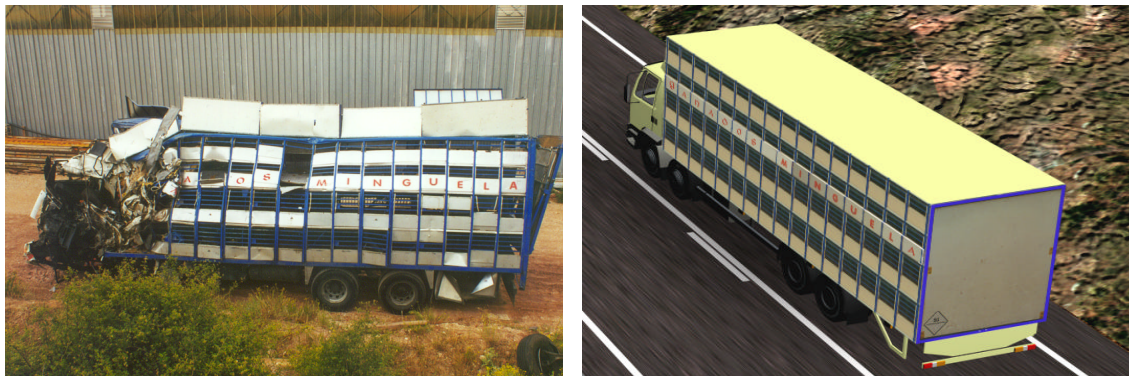
The truck is a VOLVO F12 having a kerb weight of 17100 kg, four axles and carrying livestock. A photograph and a drawing of the truck are shown in Figure 5.

Figure 5. Photograph and drawing of the truck.

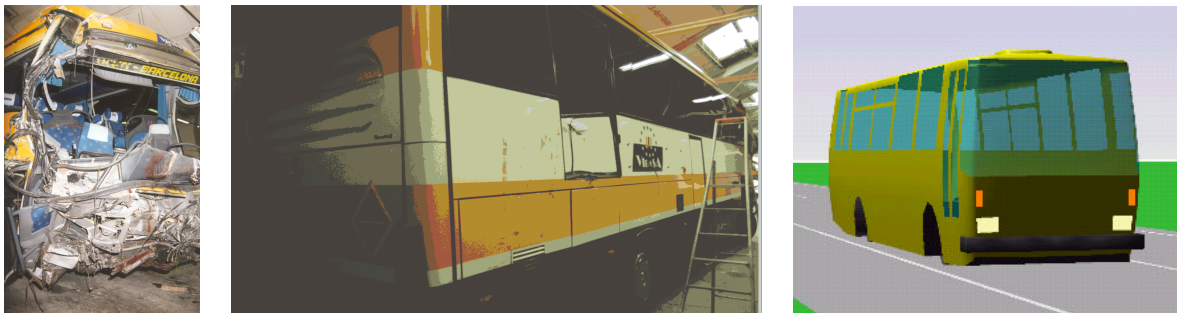
Figure 10. Photographs and model of the bus.

The bus consists of a MERCEDES BENZ O-404RH chassis and a body NOGE Touring. There are 52 seating positions, including the driver seat and one seat for a guide at the front left side of the bus. The

model for the passenger seats is FAINSA America. The kerb weight of the bus is 13640 kg and it has two axles. The front axle is single and the rear one is double.

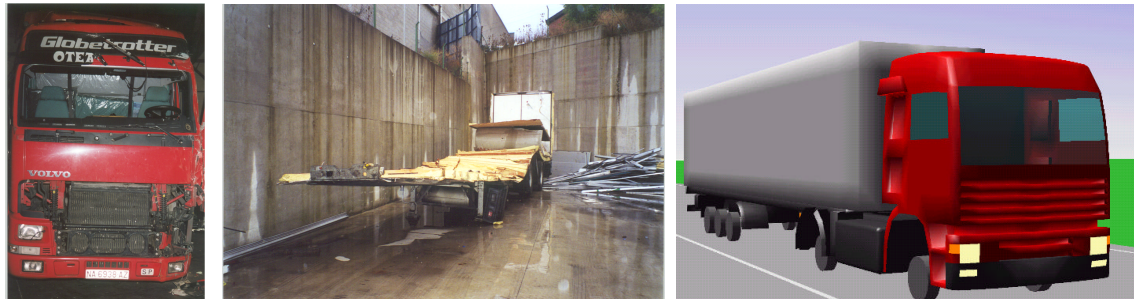
Figure 11. Photographs and model of the articulated lorry.

The lorry consists of a VOLVO FH12 tractor and a LAMBERET LVFS semitrailer. The tractor has a single front axle and a double rear axle and its kerb weight is 6300 kg. The semitrailer has three single axles with a kerb weight of 8500 kg. It was a refrigerator truck carrying tinned food and the weight of the load was calculated to be 2000 kg.
